# Bridge Element Inspection Manual

Illinois Department  
of Transportation

**Prepared by Bureau of Bridges and Structures  
Division of Highways**

**March 20, 2015  
Continually Updated Resource**

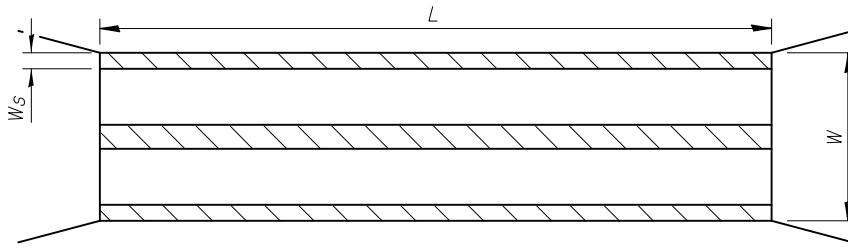
$$\text{Quantity} = L \times W = \text{SF}$$

Deteriorated areas will be measured only in the riding surface.

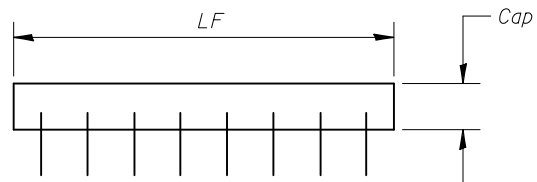
Pile Bent Cap

*3 Girders*

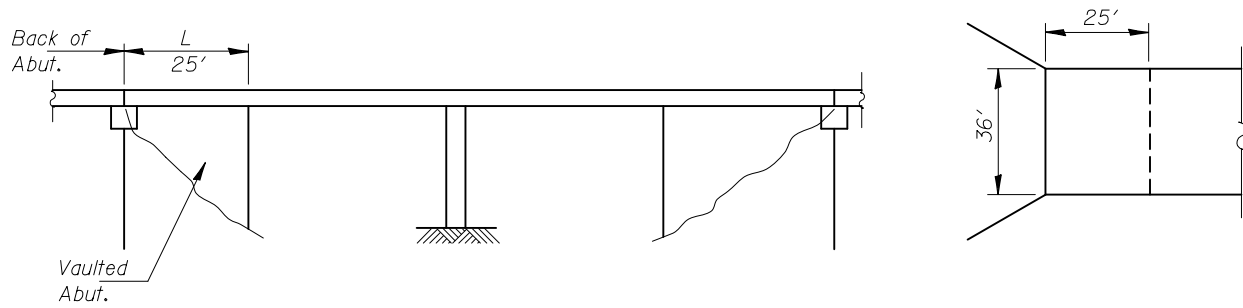
Approach Span is rigidly supported on both ends

Quantity = L x W = SF

$Q = (2)(25)(36) = 1800 \text{ SF.}$

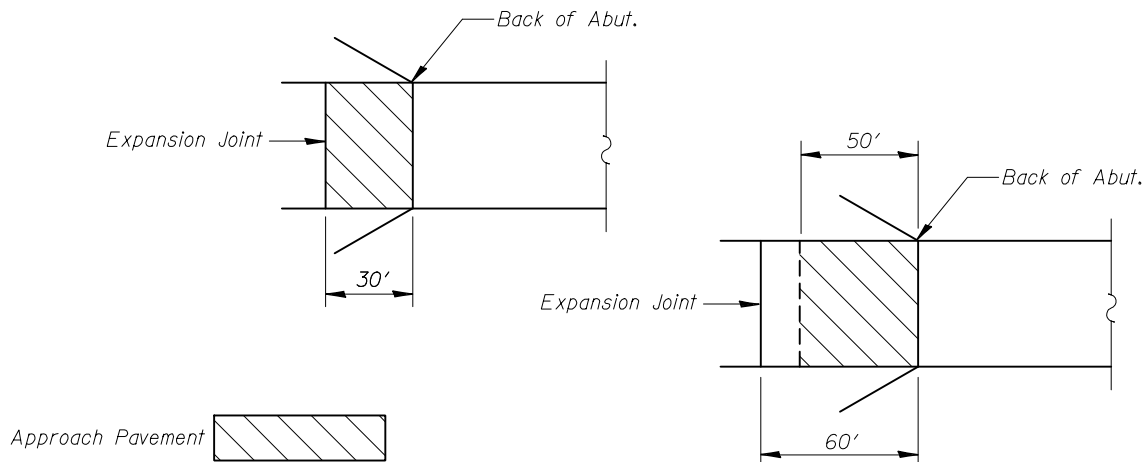
Approach Pavement is ground supported

Quantity = EA

*Maximum area of consideration 50 Ft. from back of abutment.*

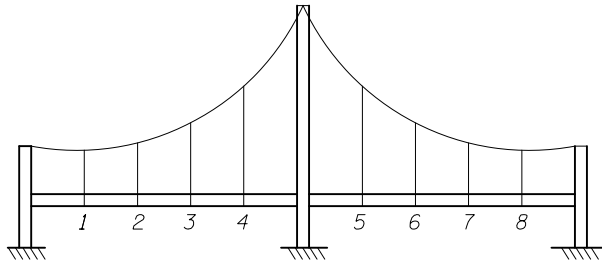
### Secondary Cable

Quantity = EA

Total Quantity= (2) \* (8) = 16EA

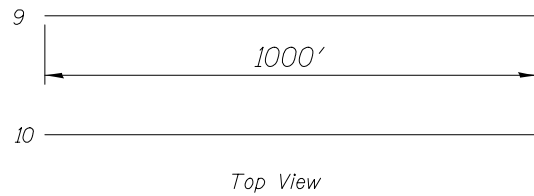
### Primary Cable

Quantity = LF

Total Quantity= (2) \* (1000') = 2000 LF  
(measured along length of cable)

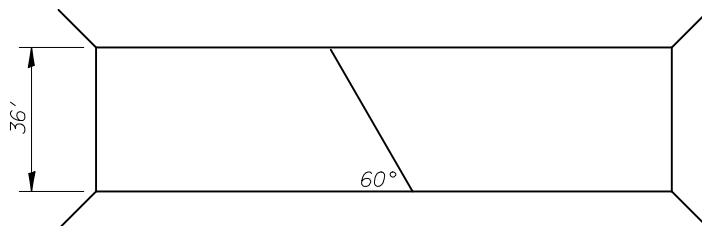
Quantity = LF

Measurements taken along joint.

$$Q = (36) / \sin 60^\circ = 41.6'$$

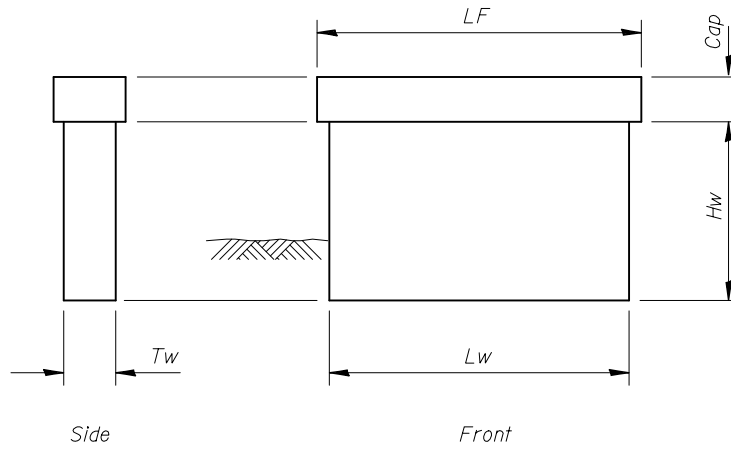
Encased Pile Bent

$$\text{Area Pier Wall} = Hw (Lw + Tw) 2$$

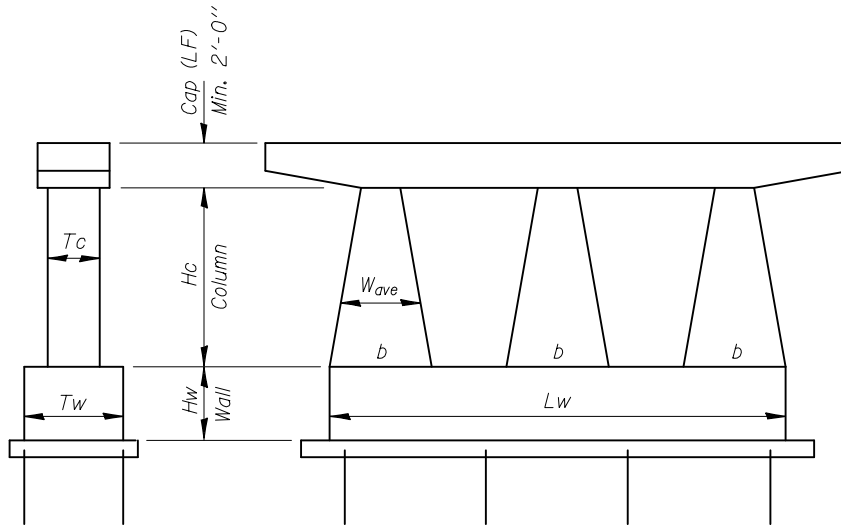
Column

$$\text{One column area} = Hc \times 2 (W_{ave} + Tc)$$

$$\text{Pier wall area} = Hw \times 2 (Lw + Tw) + (Tw \times Lw - 3b \times Tc)$$

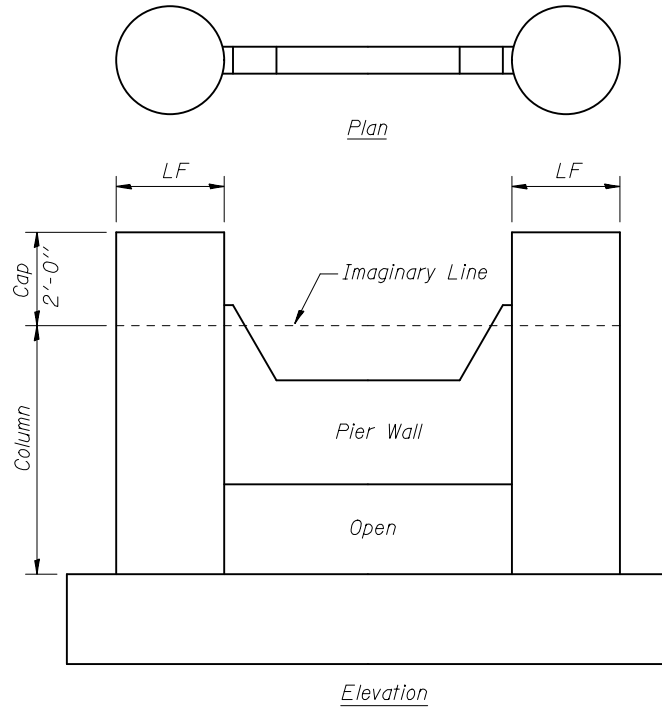
Case 1

Pier Cap

Notes: If there is no visible division between the pier wall and the cap, 2 feet below top of wall must be considered pier cap.

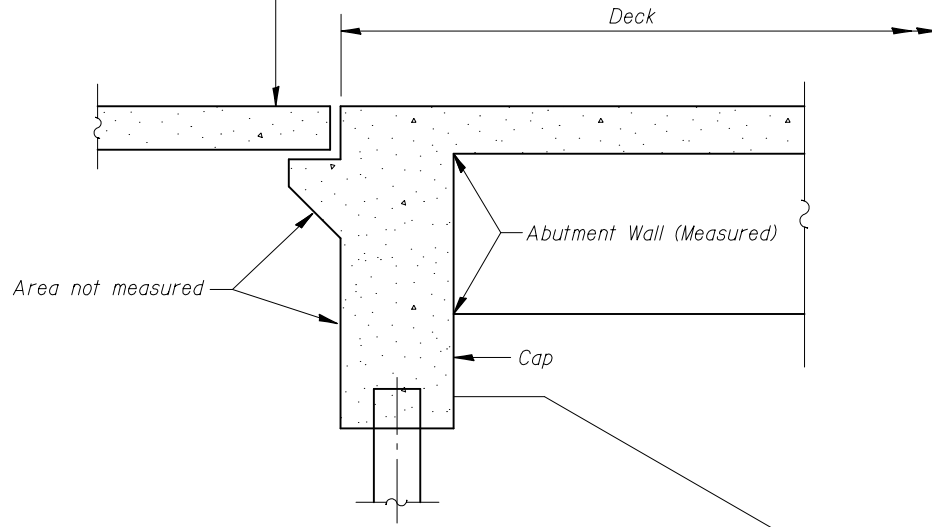
## Integral Abutment

Approach span if supported both ends  
Approach pavement if ground supported

Integral abutment must be separated into 3 elements as follows:

- 1.) Abutment wall
- 2.) Deck
- 3.) Cap

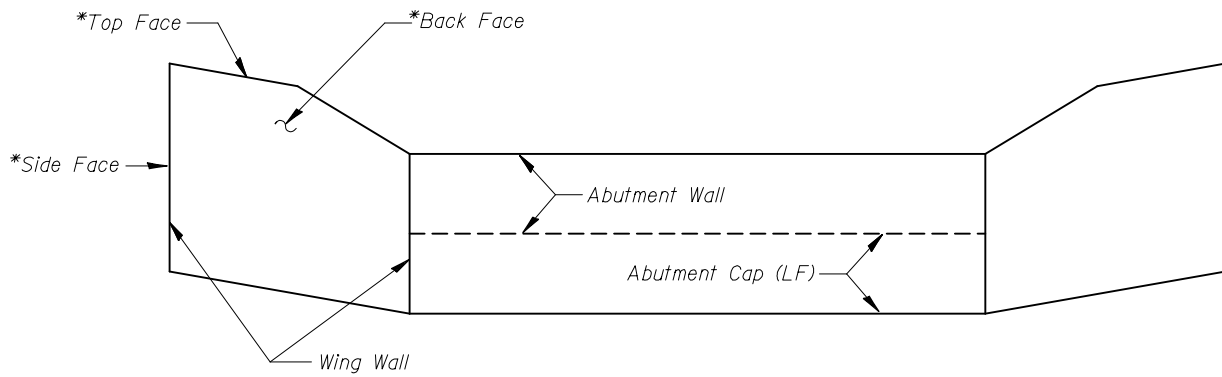
Concrete Abutment Wall and Wing Wall: measure only the front faces

\* Not Measured

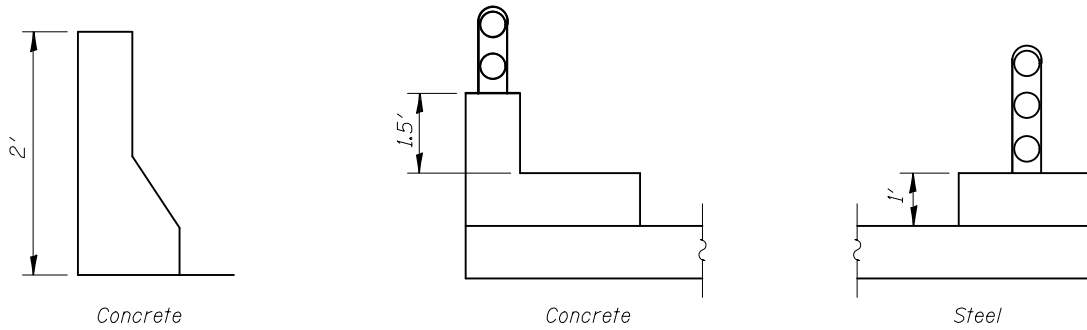
## Railing

Quantity = LF

Type of railing is determined by what material will primarily resist impact loads.

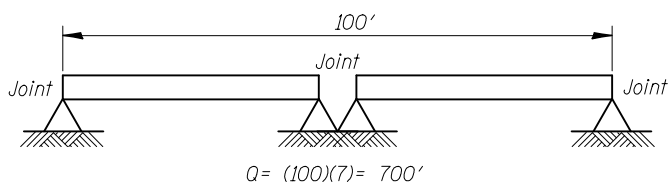
### 3. Steel Damaged Elements

Quantity = L x (# of Girders) = LF
